# DART SERVICE INSTRUCTION

TO AMEND INSTALLATION INSTRUCTIONS IIN-D407-797-1 REV. B AND EARLIER,  
INSTALLATION INSTRUCTIONS IIN-D206-797-2 REV. B AND EARLIER, AND  
INSTRUCTIONS FOR CONTINUED AIRWORTHINESS ICA-D407-797 REV. 1 AND EARLIER

WASHER CHANGE	NTS
DATE	13.06.06	COPYRIGHT © 2013 BY DART AEROSPACE LTD THIS DOCUMENT IS PRIVATE AND CONFIDENTIAL AND IS SUPPLIED ON THE EXPRESS CONDITION THAT IT IS NOT TO BE USED FOR ANY PURPOSE OR COPIED OR COMMUNICATED TO ANY OTHER PERSON WITHOUT WRITTEN PERMISSION FROM DART AEROSPACE LTD.

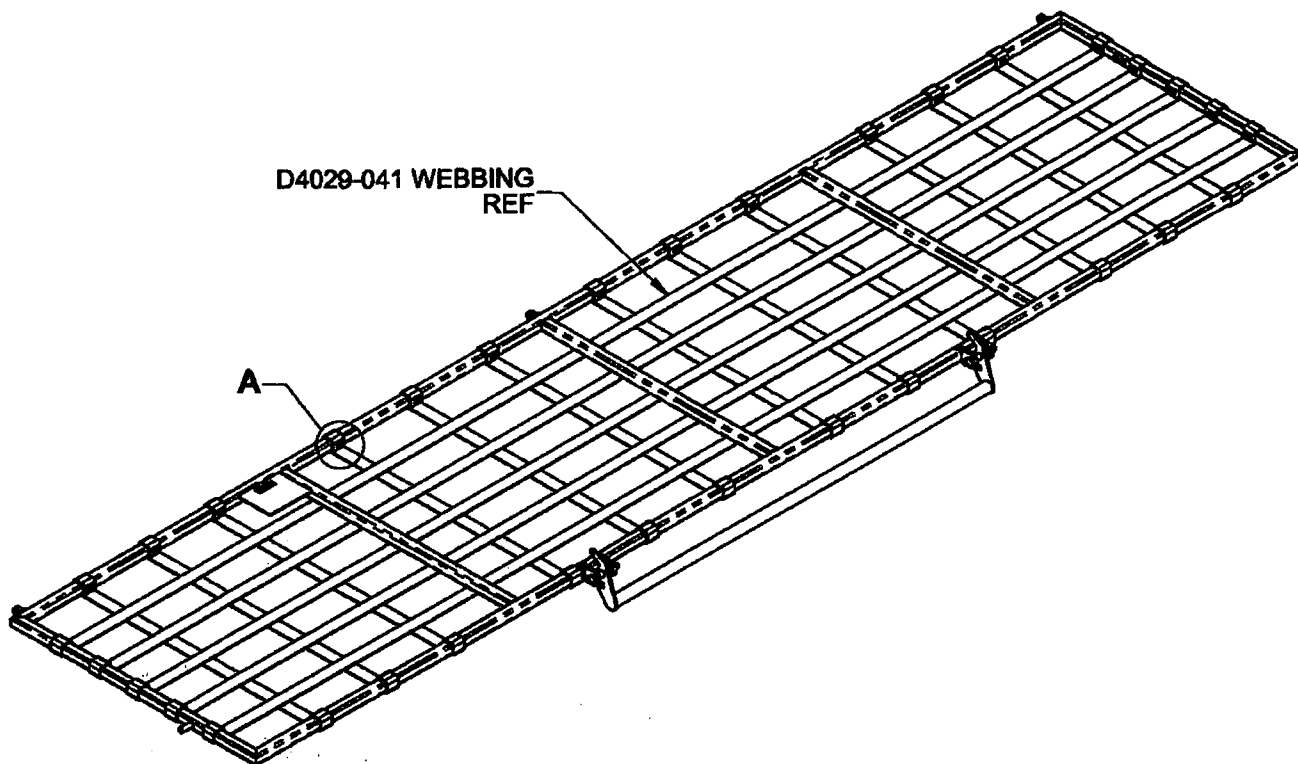
**FIGURE 1: D3915-041 BASKET LID ASSY (LIGHT WEIGHT)**

It has come to DART's attention that the webbing strands of the cargo net riveted to the structure of the lightweight lids on D407-797-013/-014 and D206-797-023/-024 Hell-Utility-Baskets at CHG 004 and earlier may pull through the small washer and rivet head and detach during operation.

The purpose of this service instruction is to provide parts and instructions to replace the NAS1149DN416J Washers and MS20600AD4W3 Rivets fastening the webbing strands of the cargo net onto the structure of the lightweight lids with NAS1149DN949J Washers and MS20600AD4W4 Rivets.

- 2.1 Carefully remove existing rivets and washers attaching the webbing to the lid frame without enlarging holes in the webbing or the lid frame.
- 2.2 Inspect the basket lid structure in accordance with ICA-D407-797. It is acceptable to inject Sikaflex -241/-291 or Proseal 890 or MIL-S-8802 Class B2 sealant into the lid structure to trap rivet debris inside the tubular structure. Repair and touch up finish as required.
- 2.3 Inspect the D4029-041 Webbing for wear. The maximum acceptable hole size is Ø0.188" (4.8 mm). Replace the webbing if holes are larger than Ø0.188" (4.8 mm) or if the webbing is worn or cuts have been found.
- 2.4 Re-install the webbing as shown in Figure 1 of this service instruction
